Stabilization of Judah Hill landslide

V.A. Diyaljee

Alberta Transportation and Utilities, Alb., Canada

ABSTRACT: This paper addresses the approaches used during a 7-year period from 1984 to stabilize the Judah Hill landslide. Stability was maintained through shifts in road and rail alignments, use of retaining walls, and subsurface drainage using deep vertical wells.

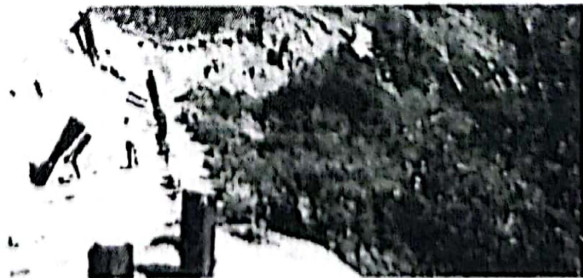
Fig.2 Timber pile wall

SH 744.04 was maintained as a gravel roadway until 1984 when a conventional asphalt pavement was constructed. Prior to 1984, there were no reported slide problems along SH 744:04. However, approximately one week after completion of the asphalt pavement the CNR reported track settlement and the development of tension cracks along their right-of-way in the immediate vicinity of the track crossing. Shortly afterwards an attempt was made by CNR to support the grade using timber piles (Fig.2) but this did not prove successful.

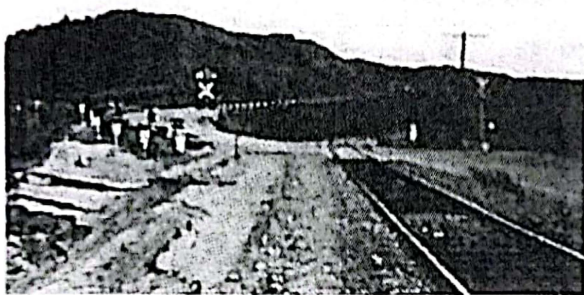
Fig.3 Roadway failure 1984-1985

During this period, the slide encroached the roadway shoulder to the east of the crossing resulting in narrowing of the roadway. Cracks and depressions were also noticeable towards centreline of the roadway. The roadway was maintained during this period by patching with asphaltic concrete. On May 29, 1985, the slide was reported to progress into the northbound lane of SH744:04 causing cracks about 25 mm wide and some settlement of the lane (Fig.3).

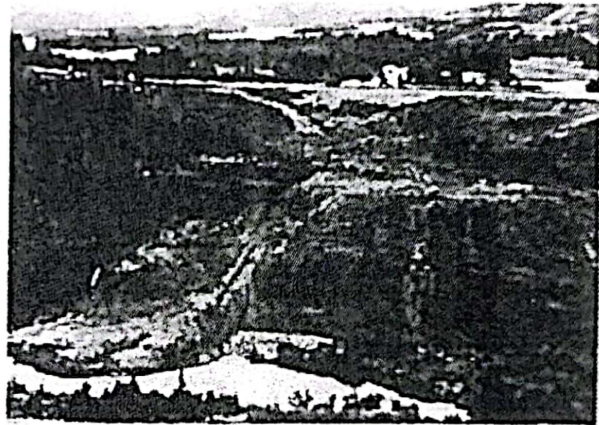
Fig.4 Failure of CNR berm

On April 26, 1987, failure of a portion of the southeast flank of the berm occurred (Fig.4) resulting in the re-establishment of the headscarp closer to the tracks. The failure of the berm also resulted in movement progressing into the roadway grade.

5. Failure of the CNR berm in 1987

was secondary to the 1984 landslide. However, evidence from 1950 to 1952 airphoto coverage suggest a pre-existing failure scarp in the same area as the 1987 failure.

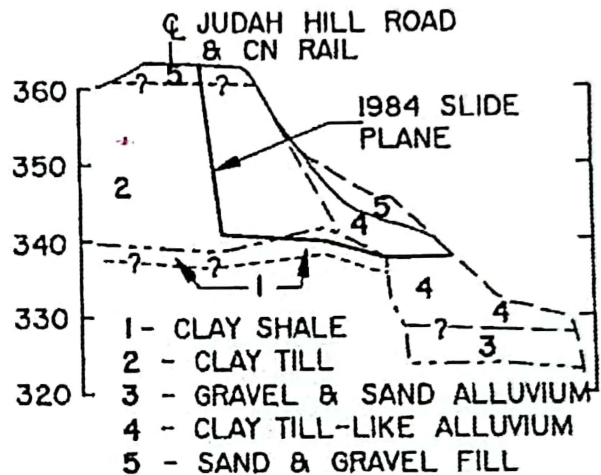
Fig.5 Section through slide

At least eight (8) discrete surficial soil units are defined in the Judah Hill slide area. Most of these soils are listed, numbered and described in Fig.5.

4. The failure surface inferred from slope indicator monitoring (Fig.5) was marginally stable.

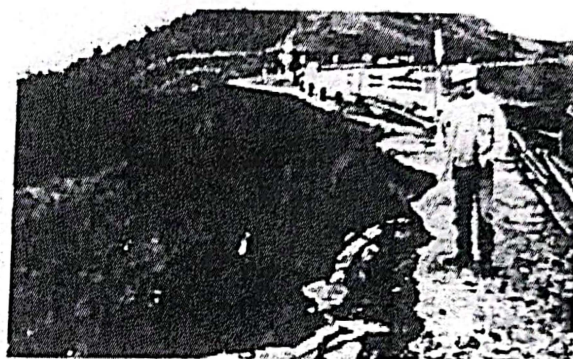
Fig.7 Failure of slope

In August 1989, approximately one year following the pile wall installation, the slope behind the pile wall slipped and exposed some of the piles (Fig.7). At the same time the slide opposite the CNR tracks was also activated and resulted in the headscarp progressing within the track location. This activity resulted in the CNR having to once again relocate their tracks further away from the slide.

Immediate action was taken to tieback the wall system as had been envisaged at the time of design.

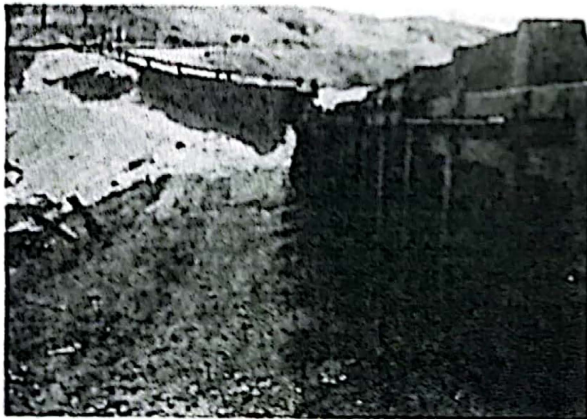
Fig.9 AT&U and CNR pile walls

Five slope inclinometers were installed parallel to the pile wall. These inclinometers have been monitored regularly and do not show any significant movements of the wall. However, some movement was noticed since the CNR wall began undergoing distress in the spring of 1990 caused by rotation of the pile wall system.

The CNR also installed a pile wall system opposite their tracks (Fig.9). This system consisted of bored piles reinforced with H-piles and timber lagging, and anchored on the opposite side of the tracks using a deadman system and tierods placed just below track level. This was part of a two stage operation which was to consist of tieback installation the following year.
