Stabilization of Judah Hill landslide

V.A. Diyaljee

Alberta Transportation and Utilities, Alb., Canada

ABSTRACT: This paper addresses the approaches used during a 7-year period from 1984 to stabilize the Judah Hill landslide. Stability was maintained through shifts in road and rail alignments, use of retaining walls, and subsurface drainage using deep vertical wells.

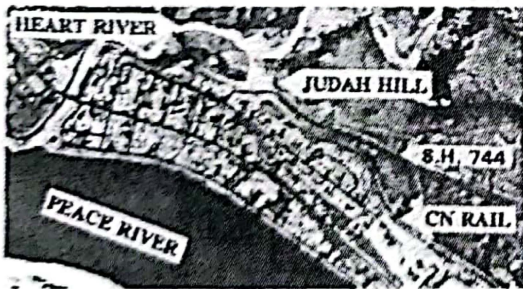
Fig.1 Location of landslide

The Judah Hill landslide (Fig.1) is located in the vicinity of the at-grade crossing of the Canadian National Railway (CNR) and Alberta Transportation and Utilities (AT&U) Secondary Highway (SH) 744:04 known as the Judah Hill road.

The general location of the slide is near the confluence of the Peace and Heart rivers where the roadway grade climbs a narrow ridge between the two rivers. The slide is situated on the valley slope of the Heart river, approximately 40 m above river level.
